# CHAPTER 13: TOWN OF CHINCOTEAGUE

## TOWN PROFILE

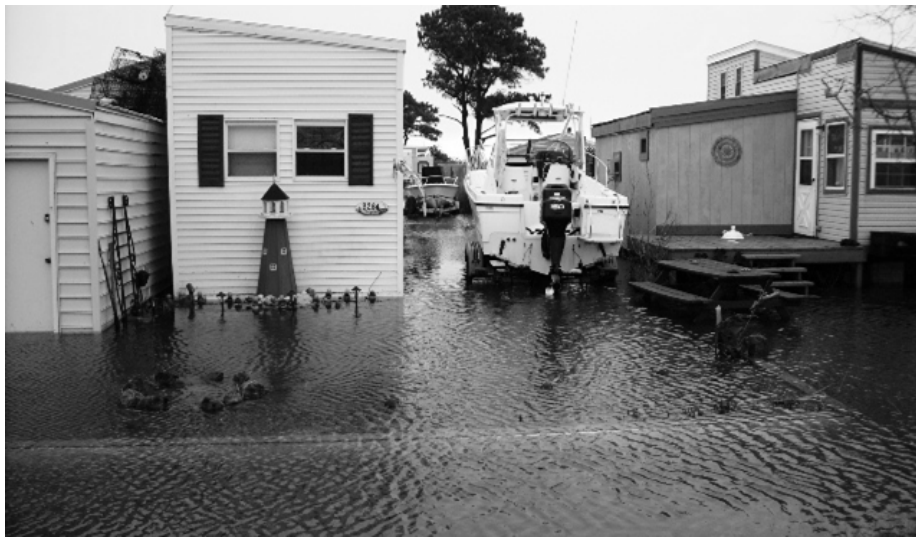
***Figure 5: Mobile Home Park in Ocean Breeze, on the Southern Tip of Chincoteague Island;  
Photo Courtesy of Captain Bob's Marina.***

The American Society of Civil Engineers (ASCE) 7-98 defines the Wind-Borne Debris Hazard Area as within 1-mile of the coast where basic wind speed is equal to or greater than 110-mph (3-second gust). Chincoteague is within the 110-120 mph range. The coast of Assateague Island and Wallops Island generally are further than 1-mile from Chincoteague. The southern tip of Chincoteague is the only place that falls near or within this zone. There are two mobile home parks in this area, one of which is featured in Figure 6. There are approximately 180 units in the park most threatened, worth approximately \$6.8 million in 2015. Assuming a 110-mph event, which is the 1%-annual-chance event in hurricane prone areas, Chincoteague could expect that many of these mobile homes would be a complete loss. It should be noted that the Floodplain Ordinance adopted by the Town in September 2006 requires elevation and anchoring for all new or substantially improved structures.
