EASTERN SHORE OF VIRGINIA PUBLIC ACCESS ASSESSMENT & BEST MANAGEMENT PRACTICES PLAN

For shoreline and launch site infrastructure resilience

Jessica Steelman, Coastal Planner
Accomack-Northampton Planning District
Commission May 2023

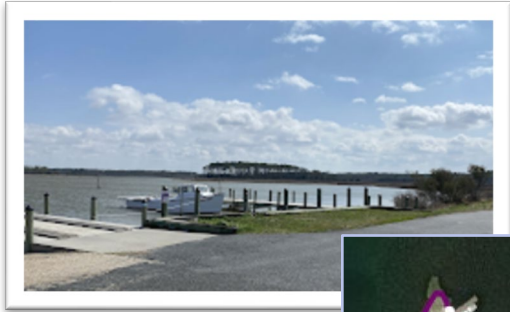
<i>Area 1</i>	
<i>Current Shoreline</i>	Undefined
<i>Structure</i>	No
<i>Exposure</i>	Low
<i>Tidal Marsh Present</i>	Marsh Present
<i>Beach Present</i>	No
<i>Nearshore Water Depth</i>	Shallow
<i>SAV Present (10-year range)</i>	No
Preferred Shoreline BMP	Highly modified area; seek expert advice

1. Ramp Replacement – Currently in the design phase

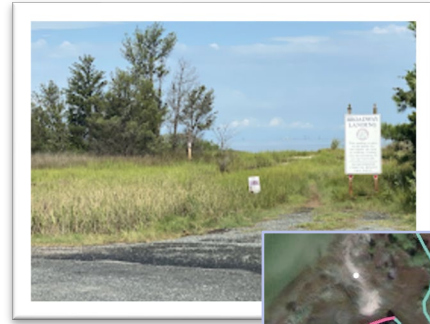
<i>Area 1</i>	
<i>Current Shoreline</i>	Undefined
<i>Structure</i>	No
<i>Exposure</i>	High
<i>Tidal Marsh Present</i>	Marsh Present
<i>Beach Present</i>	No
<i>Nearshore Water Depth</i>	Shallow
<i>SAV Present (10-year range)</i>	No
Preferred Shoreline BMP	Plant marsh with sill

<i>Area 2</i>	
<i>Current Shoreline</i>	Undefined
<i>Structure</i>	No
<i>Exposure</i>	High
<i>Tidal Marsh Present</i>	Marsh Present
<i>Beach Present</i>	No
<i>Nearshore Water Depth</i>	Shallow
<i>SAV Present (10-year range)</i>	Yes
Preferred Shoreline BMP	Ecological conflicts; seek regulatory advice

Area 3	
<i>Current Shoreline</i>	Undefended
<i>Structure</i>	No
<i>Exposure</i>	High
<i>Tidal Marsh Present</i>	No
<i>Beach Present</i>	No
<i>Nearshore Water Depth</i>	Shallow
<i>SAV Present (10-year range)</i>	No
Preferred Shoreline BMP	Maintain beach or offshore breakwater with beach nourishment

Area 4	
<i>Current Shoreline</i>	Undefended
<i>Structure</i>	No
<i>Exposure</i>	Low
<i>Tidal Marsh Present</i>	Marsh Present
<i>Beach Present</i>	No
<i>Nearshore Water Depth</i>	Shallow
<i>SAV Present (10-year range)</i>	Yes
Preferred Shoreline BMP	Non-structural living shoreline

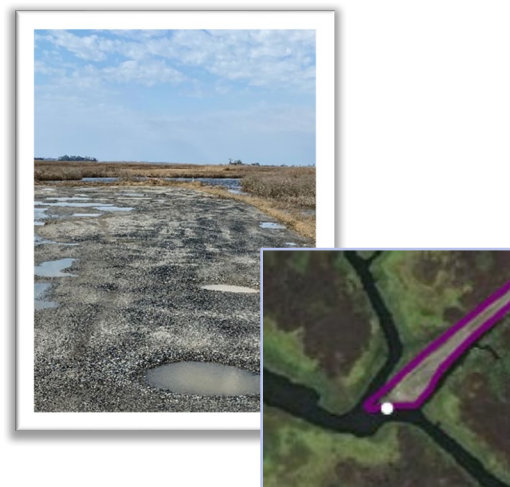
<i>Area 1</i>	
<i>Current Shoreline</i>	Undefined
<i>Structure</i>	No
<i>Exposure</i>	Low
<i>Tidal Marsh Present</i>	Marsh Present
<i>Beach Present</i>	No
<i>Nearshore Water Depth</i>	Shallow
<i>SAV Present (10-year range)</i>	No
Preferred Shoreline BMP	Highly modified; seek expert advice

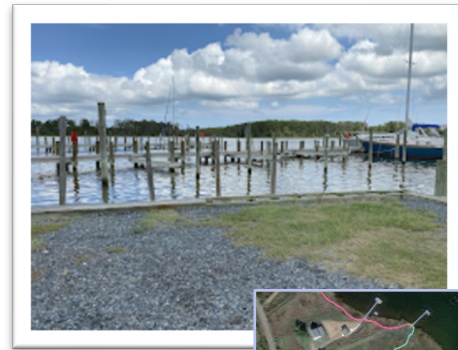
<i>Area 1</i>	
<i>Current Shoreline</i>	Defended
<i>Structure</i>	Marina
<i>Exposure</i>	Low
<i>Tidal Marsh Present</i>	No
<i>Beach Present</i>	No
<i>Nearshore Water Depth</i>	Shallow
<i>SAV Present (10-year range)</i>	No
Preferred Shoreline BMP	Highly modified area; seek expert advice

Area 2	
<i>Current Shoreline</i>	Undefended
<i>Structure</i>	No
<i>Exposure</i>	Low
<i>Tidal Marsh Present</i>	No
<i>Beach Present</i>	No
<i>Nearshore Water Depth</i>	Shallow
<i>SAV Present (10-year range)</i>	No
Preferred Shoreline BMP	Non-structural living shoreline

Area 3	
<i>Current Shoreline</i>	Undefended
<i>Structure</i>	No
<i>Exposure</i>	Low
<i>Tidal Marsh Present</i>	No
<i>Beach Present</i>	No
<i>Nearshore Water Depth</i>	Shallow
<i>SAV Present (10-year range)</i>	No
Preferred Shoreline BMP	Revetment

Area 4	
<i>Current Shoreline</i>	Undefended
<i>Structure</i>	No
<i>Exposure</i>	Low
<i>Tidal Marsh Present</i>	Marsh Present
<i>Beach Present</i>	No
<i>Nearshore Water Depth</i>	Shallow
<i>SAV Present (10-year range)</i>	No
Preferred Shoreline BMP	Plant marsh with sill

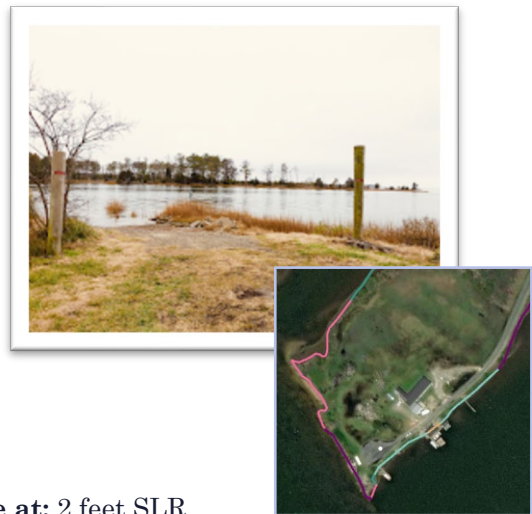
<i>Area 1</i>	
<i>Current Shoreline</i>	Undefended
<i>Structure</i>	No
<i>Exposure</i>	Low
<i>Tidal Marsh Present</i>	Marsh Present
<i>Beach Present</i>	No
<i>Nearshore Water Depth</i>	Shallow
<i>SAV Present (10-year range)</i>	No
Preferred Shoreline BMP	Plant marsh with sill

<i>Area 2</i>	
<i>Current Shoreline</i>	Undefined
<i>Structure</i>	No
<i>Exposure</i>	Low
<i>Tidal Marsh Present</i>	No
<i>Beach Present</i>	No
<i>Nearshore Water Depth</i>	Shallow
<i>SAV Present (10-year range)</i>	No
Preferred Shoreline BMP	Revetment

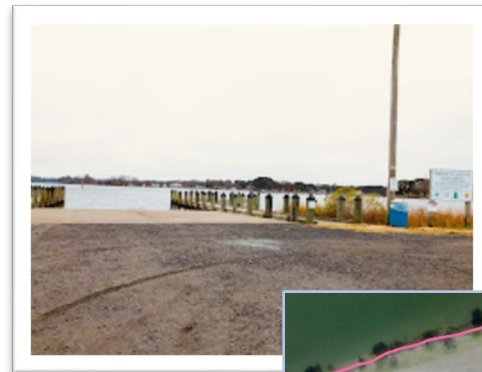
Area 1	
<i>Current Shoreline</i>	Defended
<i>Structure</i>	Revetment
<i>Exposure</i>	Low
<i>Tidal Marsh Present</i>	Marsh Present
<i>Beach Present</i>	No
<i>Nearshore Water Depth</i>	Shallow
<i>SAV Present (10-year range)</i>	Yes
Preferred Shoreline BMP	Ecological conflicts; seek regulatory advice

Area 2	
<i>Current Shoreline</i>	Undefended
<i>Structure</i>	No
<i>Exposure</i>	Low
<i>Tidal Marsh Present</i>	Marsh Present
<i>Beach Present</i>	No
<i>Nearshore Water Depth</i>	Shallow
<i>SAV Present (10-year range)</i>	No
Preferred Shoreline BMP	Highly modified area; seek expert advice

Area 3	
<i>Current Shoreline</i>	Undefended
<i>Structure</i>	No
<i>Exposure</i>	Low
<i>Tidal Marsh Present</i>	Marsh Present
<i>Beach Present</i>	No
<i>Nearshore Water Depth</i>	Shallow
<i>SAV Present (10-year range)</i>	Yes
Preferred Shoreline BMP	Ecological conflicts; seek regulatory advice

1. Stone the parking area and ramp approach
2. Install ADA parking space(s)
3. Delineate public area

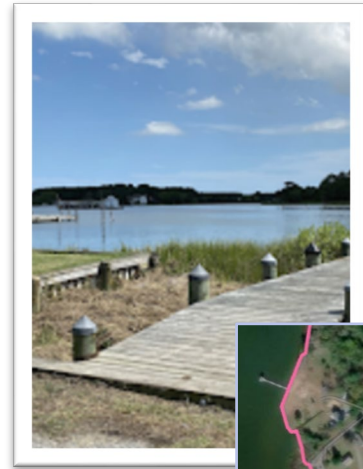
Area 1	
<i>Current Shoreline</i>	undefended
<i>Structure</i>	No
<i>Exposure</i>	Low
<i>Tidal Marsh Present</i>	Marsh Present
<i>Beach Present</i>	No
<i>Nearshore Water Depth</i>	Shallow
<i>SAV Present (10-year range)</i>	Yes
Preferred Shoreline BMP	Ecological conflicts; seek regulatory advice

Area 2	
<i>Current Shoreline</i>	Defended
<i>Structure</i>	Bulkhead
<i>Exposure</i>	Low
<i>Tidal Marsh Present</i>	Marsh Present
<i>Beach Present</i>	No
<i>Nearshore Water Depth</i>	Shallow
<i>SAV Present (10-year range)</i>	No
Preferred Shoreline BMP	Non-structural living shoreline

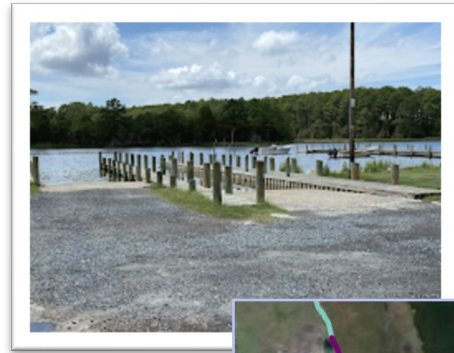
<i>Area 1</i>	
<i>Current Shoreline</i>	Undefended
<i>Structure</i>	No
<i>Exposure</i>	Low
<i>Tidal Marsh Present</i>	No
<i>Beach Present</i>	No
<i>Nearshore Water Depth</i>	Deep
<i>SAV Present (10-year range)</i>	No
Preferred Shoreline BMP	Revetment

1. Replacement of drive-on dock

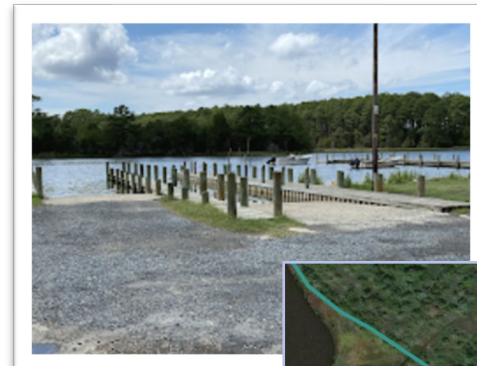
Sea Level Rise Begins to Impact this Launch Site at: 2 feet SLR

<i>Area 1</i>	
<i>Current Shoreline</i>	Undefined
<i>Structure</i>	No
<i>Exposure</i>	Low
<i>Tidal Marsh Present</i>	Marsh Present
<i>Beach Present</i>	No
<i>Nearshore Water Depth</i>	Shallow
<i>SAV Present (10-year range)</i>	No
Preferred Shoreline BMP	Non-structural living shoreline

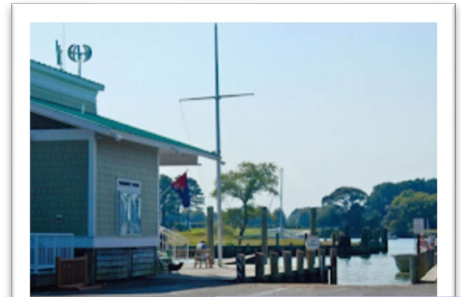
<i>Area 1</i>	
<i>Current Shoreline</i>	Defended
<i>Structure</i>	Marina
<i>Exposure</i>	Low
<i>Tidal Marsh Present</i>	No
<i>Beach Present</i>	No
<i>Nearshore Water Depth</i>	Deep
<i>SAV Present (10-year range)</i>	No
Preferred Shoreline BMP	Highly modified area; seek expert advice

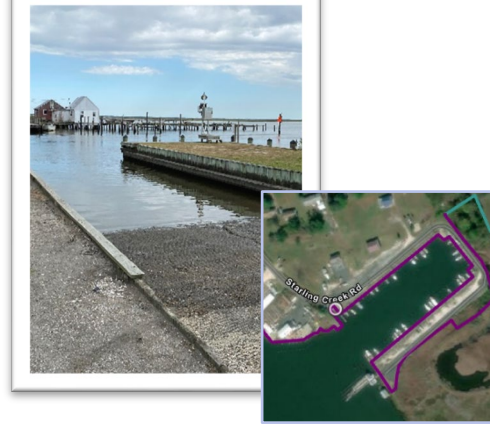
<i>Area 1</i>	
<i>Current Shoreline</i>	Undefended
<i>Structure</i>	No
<i>Exposure</i>	Low
<i>Tidal Marsh Present</i>	Marsh Present
<i>Beach Present</i>	No
<i>Nearshore Water Depth</i>	Deep
<i>SAV Present (10-year range)</i>	No
Preferred Shoreline BMP	Highly modified area; seek expert advice

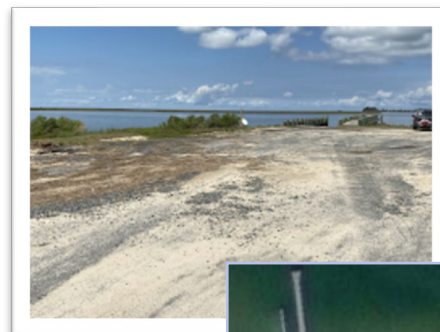
Sea Level Rise Begins to Impact this Launch Site at: 2 feet SLR

1. Boat ramp replacement – completed 2022
2. Replace decking on dock

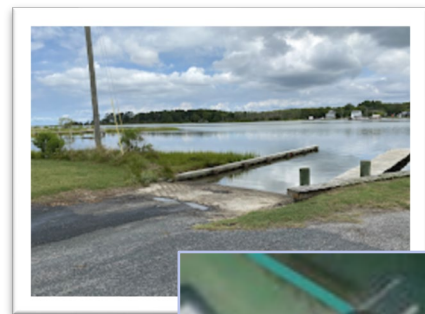
Sea Level Rise Begins to Impact this Launch Site at: 2 feet SLR

Area 1	
<i>Current Shoreline</i>	Undefined
<i>Structure</i>	No
<i>Exposure</i>	Low
<i>Tidal Marsh Present</i>	Marsh Present
<i>Beach Present</i>	No
<i>Nearshore Water Depth</i>	Shallow
<i>SAV Present (10-year range)</i>	No
Preferred Shoreline BMP	Non-structural living shoreline

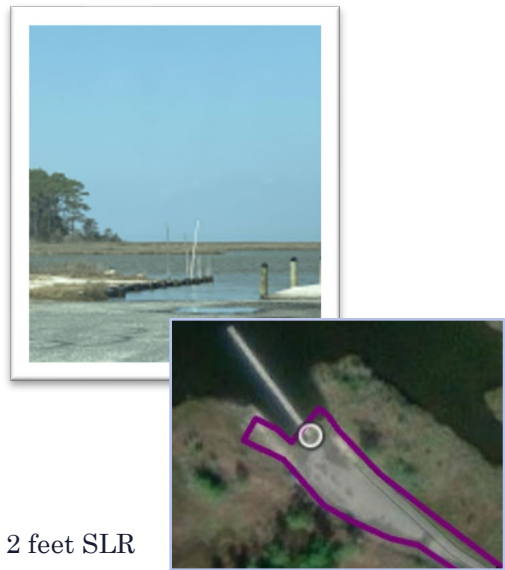
Area 1	
<i>Current Shoreline</i>	Undefended
<i>Structure</i>	No
<i>Exposure</i>	Low
<i>Tidal Marsh Present</i>	Marsh Present
<i>Beach Present</i>	No
<i>Nearshore Water Depth</i>	Shallow
<i>SAV Present (10-year range)</i>	No
Preferred Shoreline BMP	Non-structural living shoreline

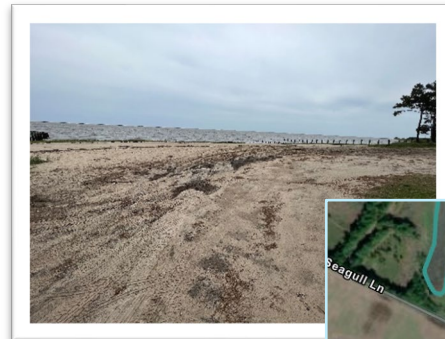
Sea Level Rise Begins to Impact this Launch Site at: 4 feet SLR

Area 1	
<i>Current Shoreline</i>	Undefended
<i>Structure</i>	No
<i>Exposure</i>	High
<i>Tidal Marsh Present</i>	Marsh Present
<i>Beach Present</i>	No
<i>Nearshore Water Depth</i>	Shallow
<i>SAV Present (10-year range)</i>	No
Preferred Shoreline BMP	Plant marsh with sill

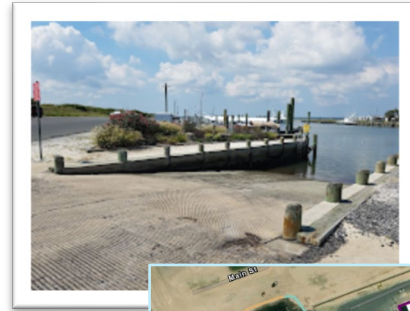
Area 1	
<i>Current Shoreline</i>	Undefined
<i>Structure</i>	No
<i>Exposure</i>	Low
<i>Tidal Marsh Present</i>	No
<i>Beach Present</i>	No
<i>Nearshore Water Depth</i>	Deep
<i>SAV Present (10-year range)</i>	No
Preferred Shoreline BMP	Revetment

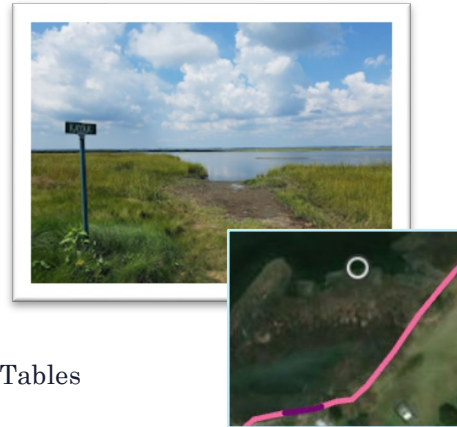
Area 1	
<i>Current Shoreline</i>	undefended
<i>Structure</i>	No
<i>Exposure</i>	High
<i>Tidal Marsh Present</i>	Marsh Present
<i>Beach Present</i>	No
<i>Nearshore Water Depth</i>	Shallow
<i>SAV Present (10-year range)</i>	Yes
Preferred Shoreline BMP	Ecological conflicts; seek regulatory advice

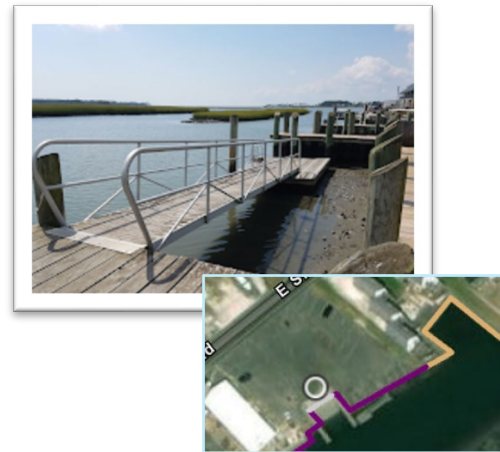
Area 1	
<i>Current Shoreline</i>	Defended
<i>Structure</i>	Bulkhead
<i>Exposure</i>	Low
<i>Tidal Marsh Present</i>	Marsh Present
<i>Beach Present</i>	No
<i>Nearshore Water Depth</i>	Deep
<i>SAV Present (10-year range)</i>	No
Preferred Shoreline BMP	Revetment

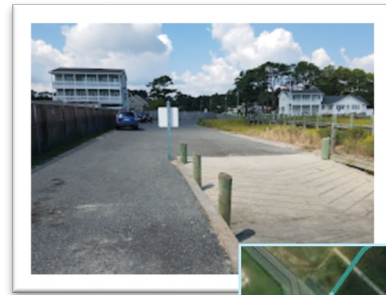
Area 1	
<i>Current Shoreline</i>	undefended
<i>Structure</i>	No
<i>Exposure</i>	Low
<i>Tidal Marsh Present</i>	Marsh Present
<i>Beach Present</i>	No
<i>Nearshore Water Depth</i>	Deep
<i>SAV Present (10-year range)</i>	No
Preferred Shoreline BMP	Plant marsh with sill

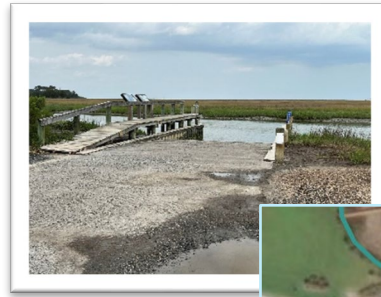
Area 1	
<i>Current Shoreline</i>	Undefined
<i>Structure</i>	No
<i>Exposure</i>	Low
<i>Tidal Marsh Present</i>	Marsh Present
<i>Beach Present</i>	No
<i>Nearshore Water Depth</i>	Shallow
<i>SAV Present (10-year range)</i>	No
Preferred Shoreline BMP	Non-structural living shoreline

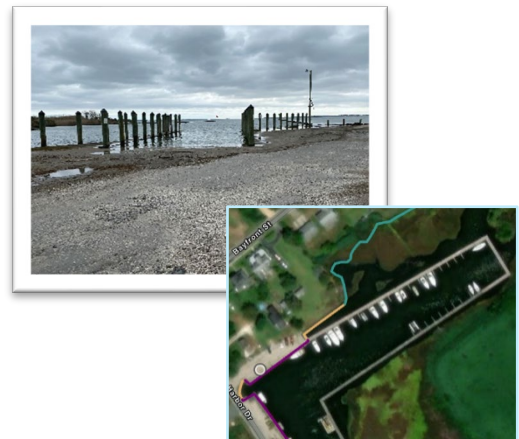
Area 1	
<i>Current Shoreline</i>	Undefined
<i>Structure</i>	No
<i>Exposure</i>	Low
<i>Tidal Marsh Present</i>	Marsh present
<i>Beach Present</i>	No
<i>Nearshore Water Depth</i>	Shallow
<i>SAV Present (10-year range)</i>	No
Preferred Shoreline BMP	Non-structural living shoreline

1. Pier replacement – last section
2. Electrical improvements for critical slips
3. Parking area improvements

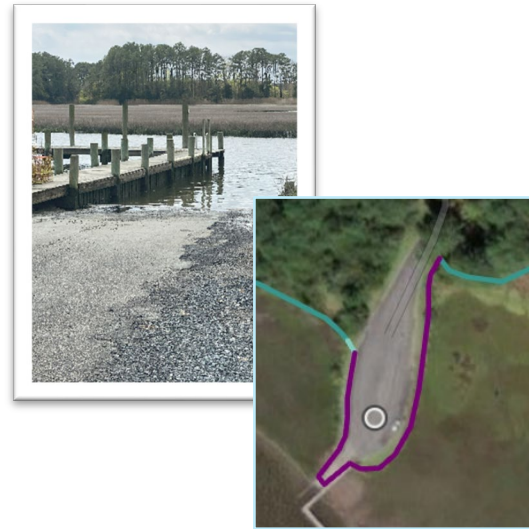
Area 1	
<i>Current Shoreline</i>	Undefined
<i>Structure</i>	No
<i>Exposure</i>	Low
<i>Tidal Marsh Present</i>	Marsh present
<i>Beach Present</i>	No
<i>Nearshore Water Depth</i>	Shallow
<i>SAV Present (10-year range)</i>	No
Preferred Shoreline BMP	Non-structural living shoreline

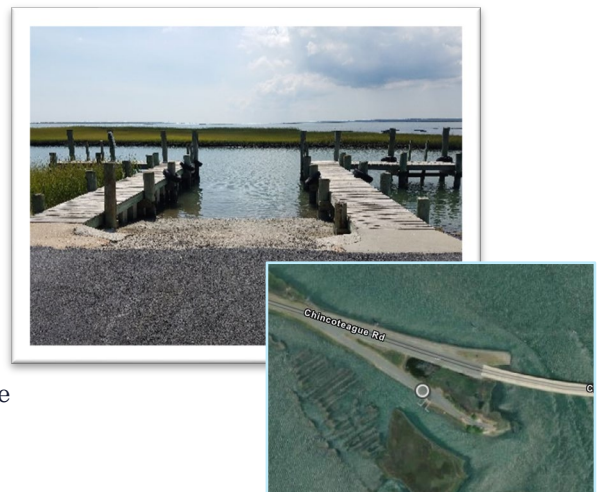
Sea Level Rise Begins to Impact this Launch Site at: 2 feet SLR

Condition of Shoreline Areas Surrounding this Launch Site: No data available

1. Ramp replacement – completed 2022

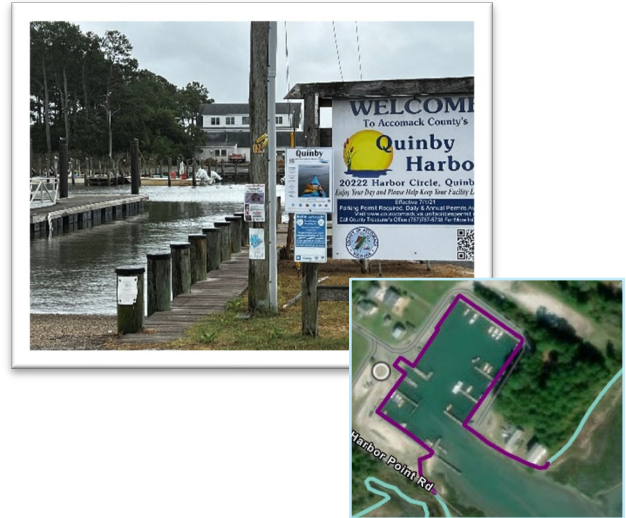
Area 1	
<i>Current Shoreline</i>	Undefined
<i>Structure</i>	No
<i>Exposure</i>	Moderate
<i>Tidal Marsh Present</i>	Marsh Present
<i>Beach Present</i>	No
<i>Nearshore Water Depth</i>	Deep
<i>SAV Present (10-year range)</i>	No
Preferred Shoreline BMP	Plant marsh with sill

1. Bulkhead replacement – completed 2022

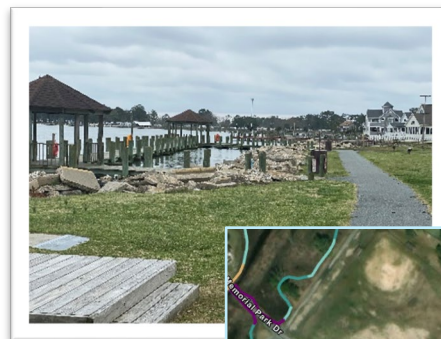
Sea Level Rise Begins to Impact this Launch Site at: 4 feet SLR

Area 1	
<i>Current Shoreline</i>	Undefended
<i>Structure</i>	No
<i>Exposure</i>	Low
<i>Tidal Marsh Present</i>	No
<i>Beach Present</i>	No
<i>Nearshore Water Depth</i>	Deep
<i>SAV Present (10-year range)</i>	No
Preferred Shoreline BMP	Highly modified area; seek expert advice

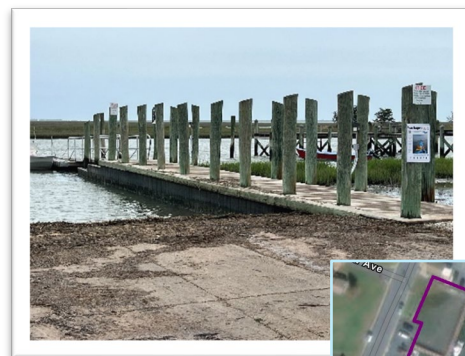
Area 1	
<i>Current Shoreline</i>	Defended
<i>Structure</i>	Marina
<i>Exposure</i>	Low
<i>Tidal Marsh Present</i>	No
<i>Beach Present</i>	No
<i>Nearshore Water Depth</i>	Deep
<i>SAV Present (10-year range)</i>	No
Preferred Shoreline BMP	Highly modified area; seek expert advice

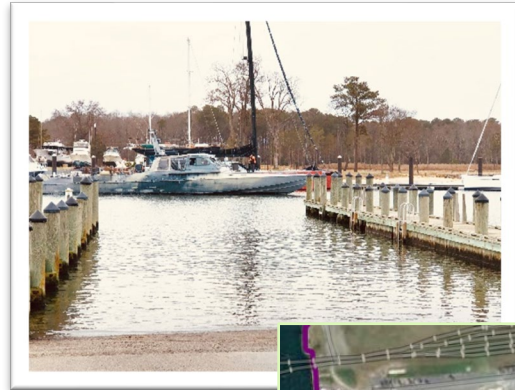
Area 1	
<i>Current Shoreline</i>	Defended
<i>Structure</i>	Marina
<i>Exposure</i>	Low
<i>Tidal Marsh Present</i>	No
<i>Beach Present</i>	No
<i>Nearshore Water Depth</i>	Deep
<i>SAV Present (10-year range)</i>	No
Preferred Shoreline BMP	Highly modified area; seek expert advice

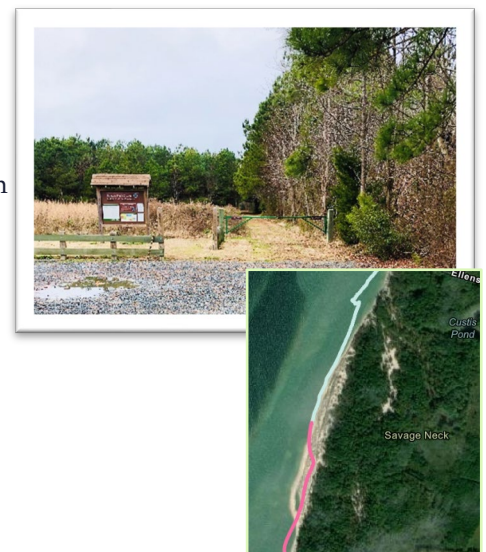
Area 1	
<i>Current Shoreline</i>	undefended
<i>Structure</i>	No
<i>Exposure</i>	High
<i>Tidal Marsh Present</i>	No
<i>Beach Present</i>	Yes
<i>Nearshore Water Depth</i>	Shallow
<i>SAV Present (10-year range)</i>	No
Preferred Shoreline BMP	Maintain beach or offshore breakwater with beach nourishment

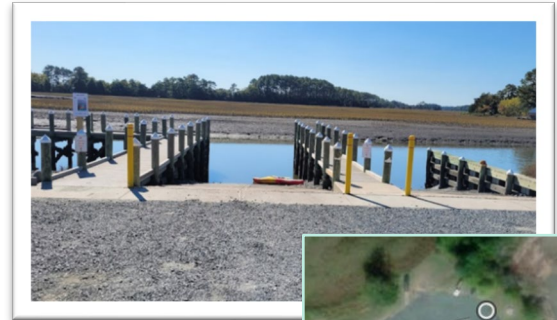
Area 1	
<i>Current Shoreline</i>	Defended
<i>Structure</i>	Debris
<i>Exposure</i>	Low
<i>Tidal Marsh Present</i>	Marsh present
<i>Beach Present</i>	No
<i>Nearshore Water Depth</i>	Shallow
<i>SAV Present (10-year range)</i>	No
Preferred Shoreline BMP	Non-structural living shoreline

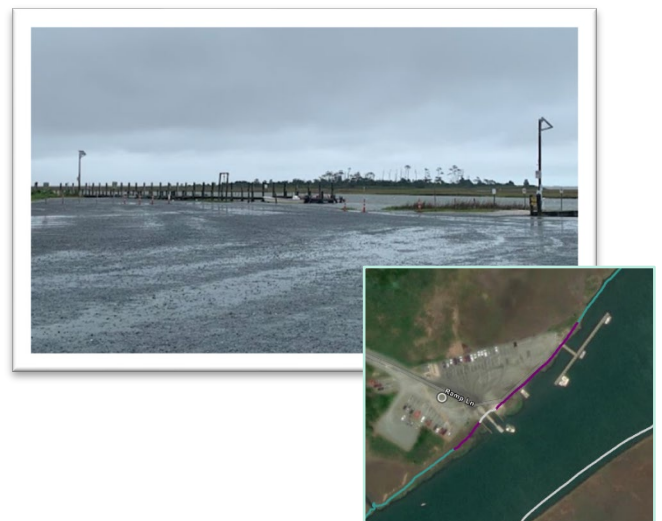
Sea Level Rise Begins to Impact this Launch Site at: 2 feet SLR

Area 1	
<i>Current Shoreline</i>	Undefended
<i>Structure</i>	No
<i>Exposure</i>	Low
<i>Tidal Marsh Present</i>	Marsh present
<i>Beach Present</i>	No
<i>Nearshore Water Depth</i>	Shallow
<i>SAV Present (10-year range)</i>	No
Preferred Shoreline BMP	Non-structural living shoreline

1. Construction of kayak dock - completed 2023
