Groundwater Quality Assessment of Private Well Water in Cheapside and East Horntown, Virginia

Report Submitted to the
Accomack-Northampton Planning District Commission
June 2013

TECHNICAL REPORT: RMC-EVST 2013-1

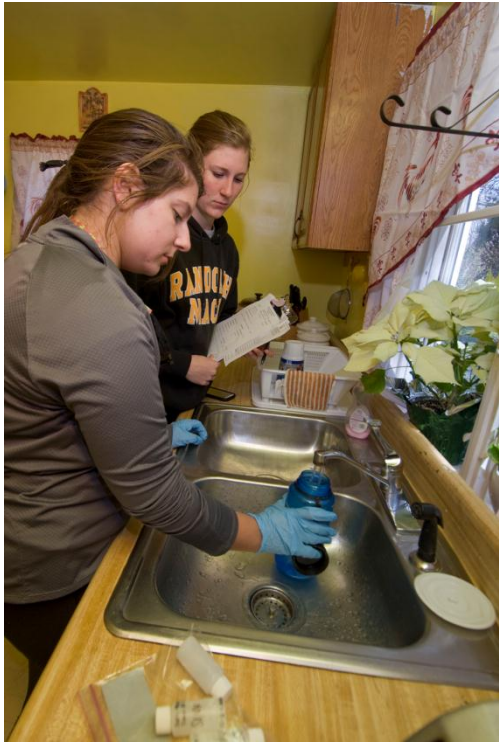
Figure 3. Randolph-Macon College students obtaining a faucet sample at a resident in the Cheapside community on the Eastern Shore of Virginia.

faucet sampled, we collected one sample for coliform bacteria and an additional 1L of water for other parameters that required a lab analysis (Figure 3).

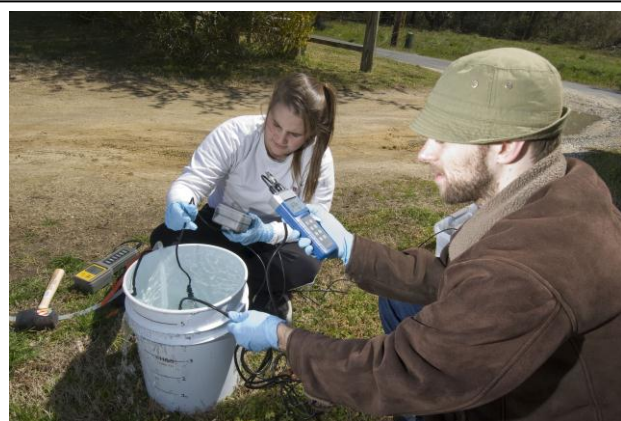
Figure 4. Parameter measurements made by Randolph-Macon College students during the purging processes.

the volume of the well as per USGS protocol (Myers 2006). During this purging process, we obtained measurements every 5-10 minutes for dissolved oxygen (DO), turbidity, pH, conductivity, specific conductance, salinity, and temperature using the devices YSI 55, YSI 30, pH 100, HACH 2100P Turbidimeter (Figure 4). Once purging was complete and measured parameters reached stable values, we collected another coliform bacteria sample and 1L of water for lab testing of additional parameters.

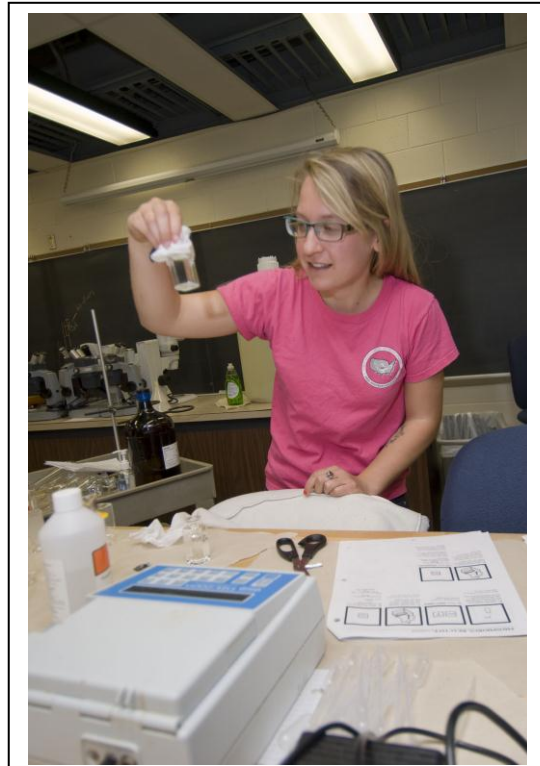
Figure 5. Lab analysis of nitrates at Randolph-Macon College.

Ferrous iron, surfactants, nitrate, sulfate, and phosphate were tested using the HACH DR/ 2000 spectrophotometer with methods outlined by HACH. Total dissolved solids (TDS) were tested using HACH methods (Figure 5). For all samples, appropriate QA/QC measures were completed including instrument calibration with reagent blanks.

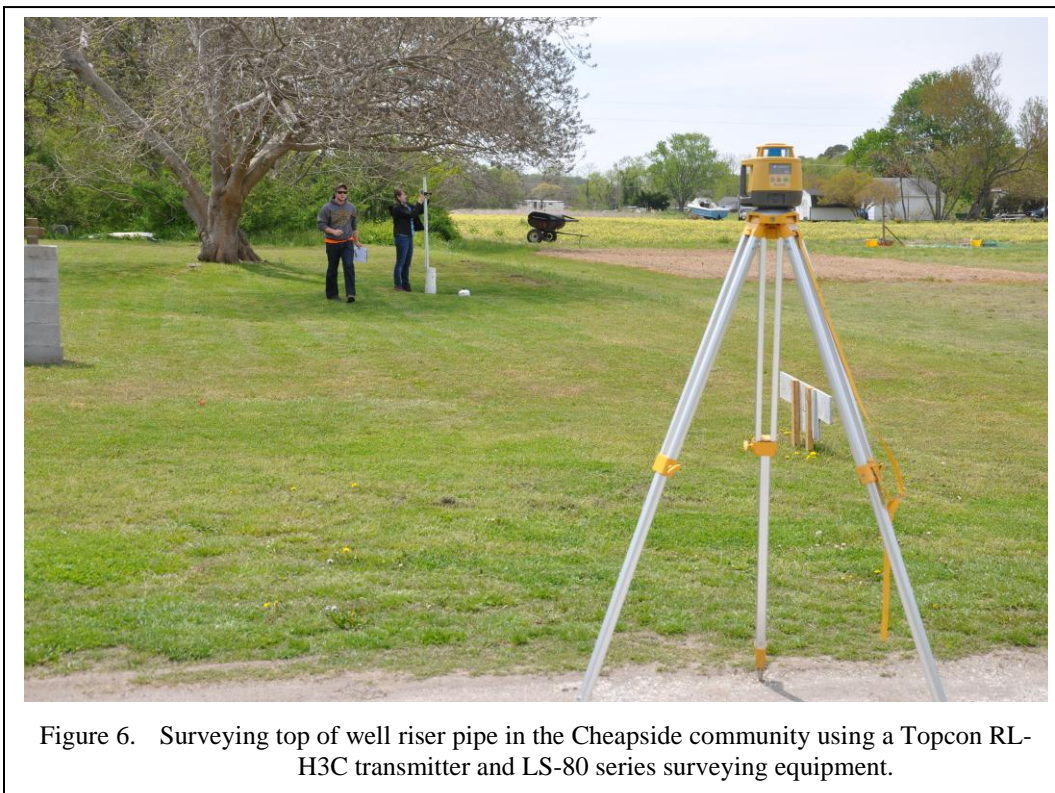
The depth to the static water level from the top of the casing at each well was determined using a Topcon RL-H3C transmitter and LS-80 series surveying equipment (Figure 6).

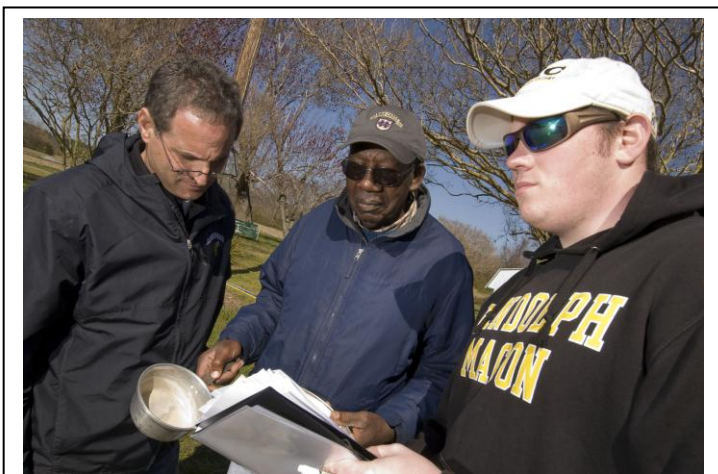
Figure 7. Cheapside community resident providing a brine sample from evaporated sink water to Randolph-Macon College students for analysis.

One of the residents gave us brine that had evaporated from pots left on his home radiator (Figure 7). We attempted a gas chromatography–mass spectrometry analysis to determine the

chemical make-up of the evaporite, but faulty equipment rendered this method unusable. Our less sophisticated method of analyzing the brine (pouring 1 HCl on it) provided CO₂ (fizz), suggesting the brine consisted, in part, of calcium carbonate – a constituent of hard water (or scale).

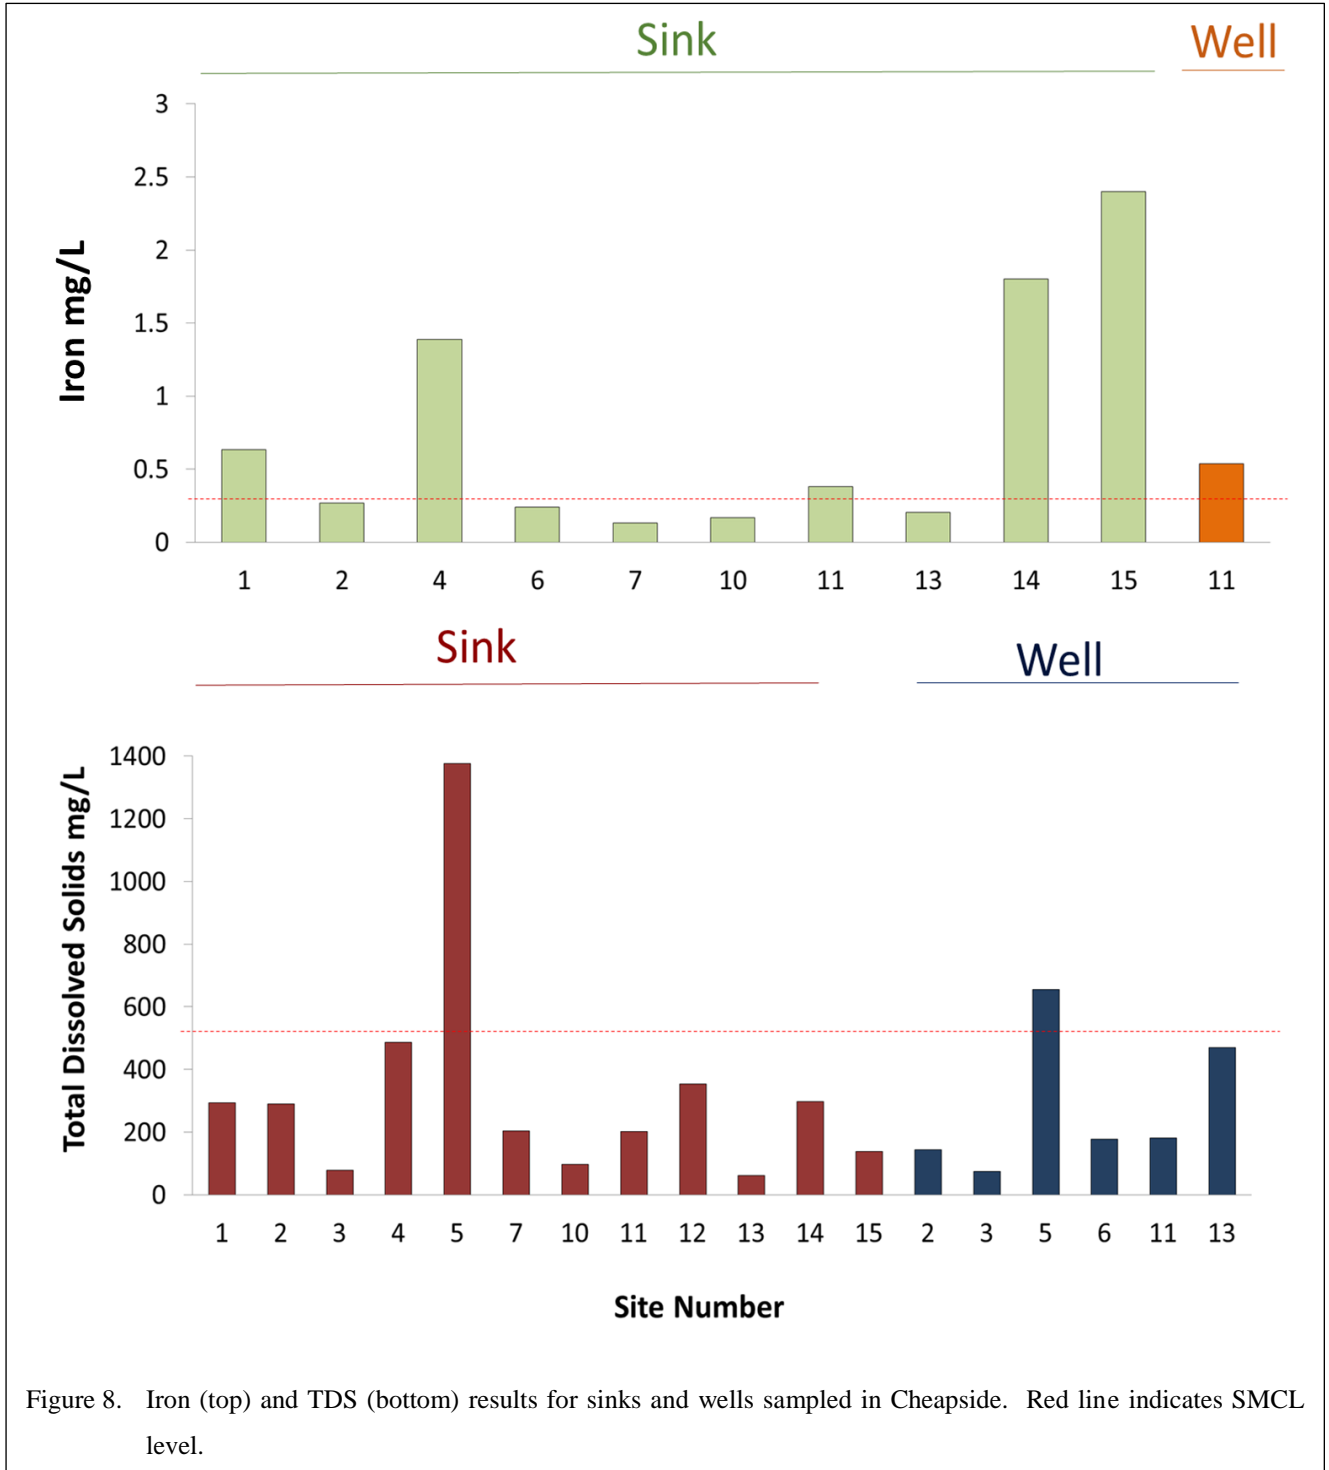
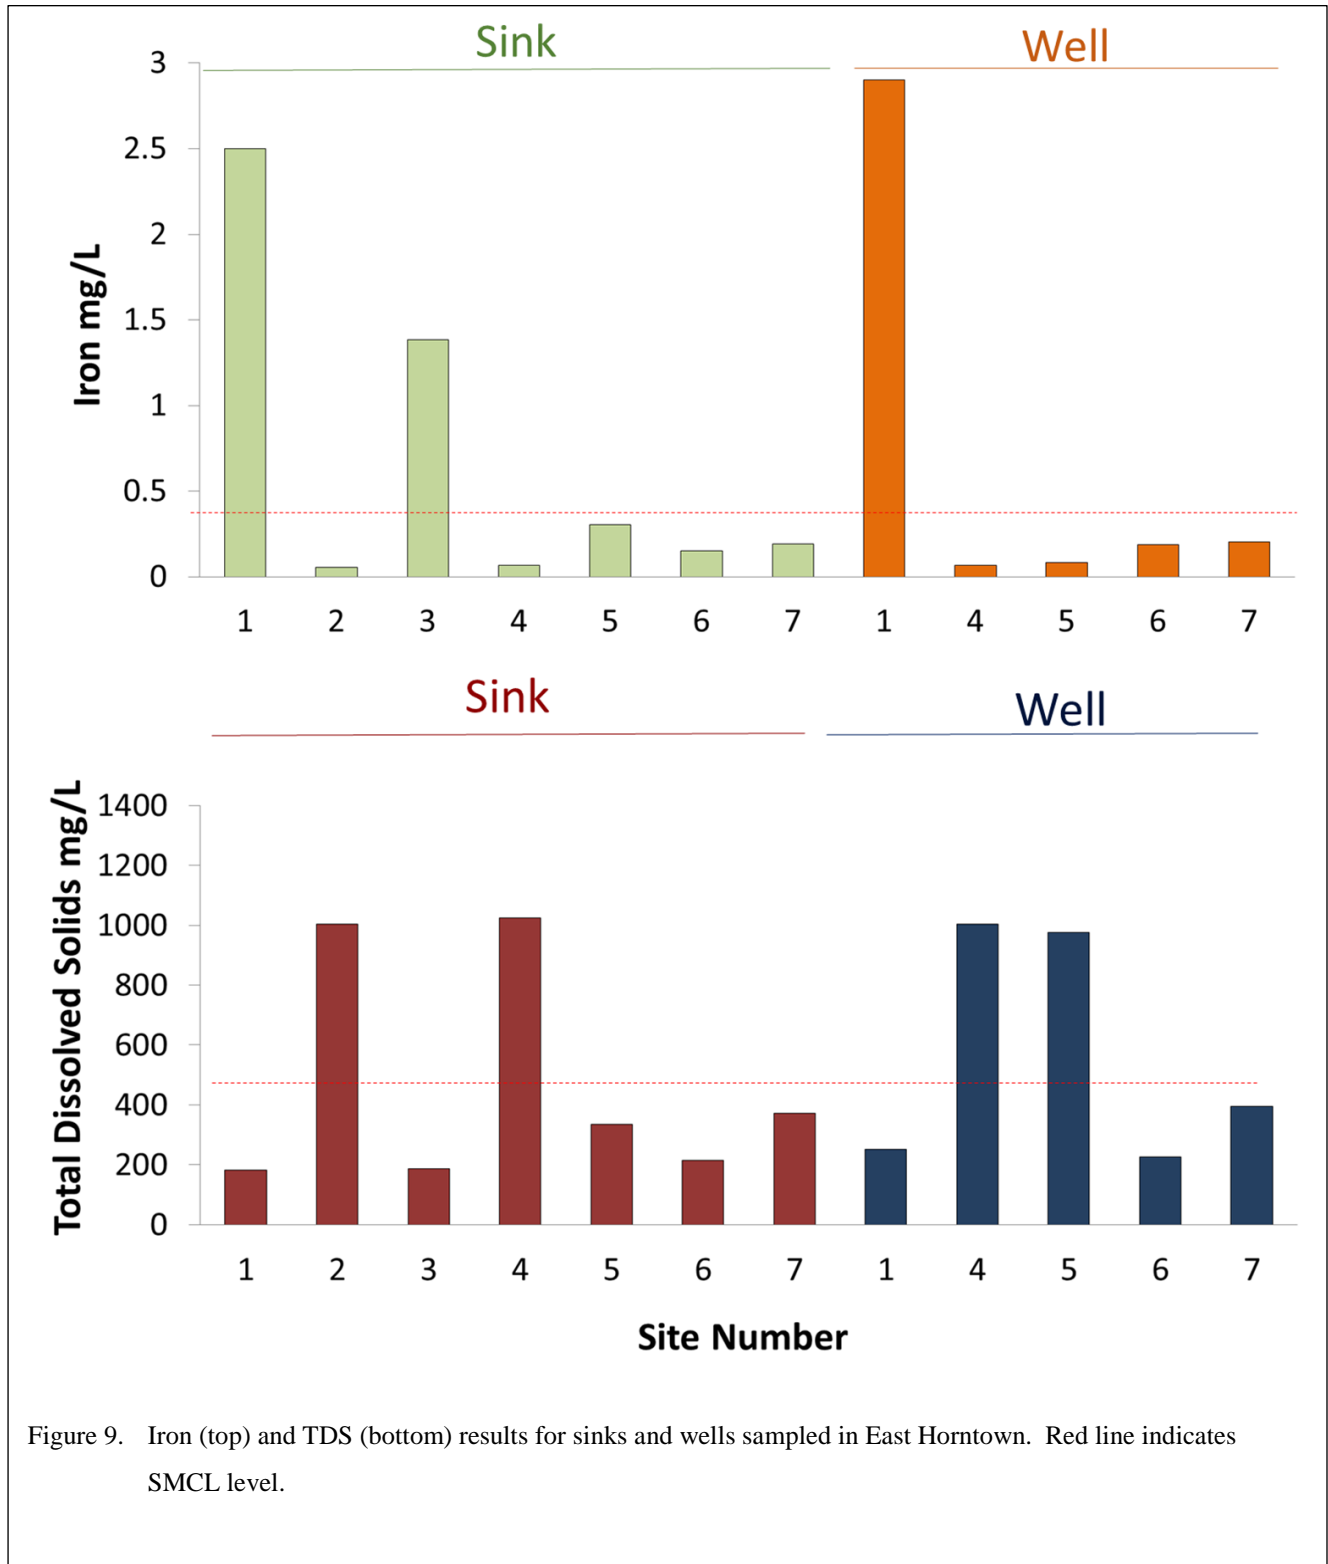
Figure 9. Iron (top) and TDS (bottom) results for sinks and wells sampled in East Horntown. Red line indicates SMCL level.

For both well and faucet samples, no residence exceeded MCL and SMCL standards for coliform, *E. coli*, nitrate, phosphate, and surfactants. Four households exceeded the iron SMCL with three of the samples coming from faucets and two samples from wells. Four households

exceeded the SMCL for TDS with two samples from faucets and two samples from wells (Figure 9, Appendix 2). Field parameter values are given in Appendix 3.
